Technical Information

Air-to-Water

Subject: Air-to-Water Mono-bloc H2O (pump abnormality) Error

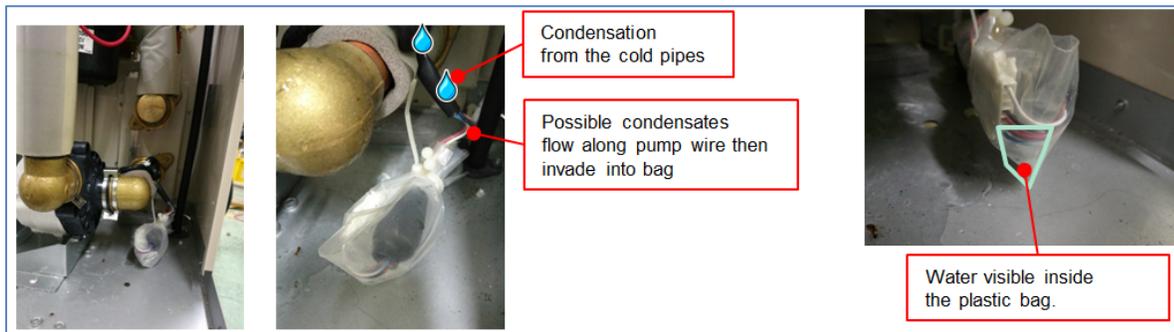
The pump leadwire connector is protected with a plastic bag but in rare cases where environmental conditions cause excessive dew formation inside the unit during cooling mode operation, condensates from cold pipes drop through the opening of the bag and accumulate inside it. This condition could lead to short circuit on the water pump wire connection when electrical power is supplied to the pump. Refer to Figure 1 for details.

When this happens, the DC pump and main PCB need to be replaced. To prevent recurrence, ensure the position of the pump connector is as shown in Figure 3 and the countermeasure (refer 3) is implemented.

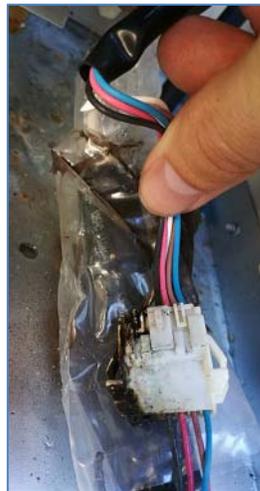
When power is supplied constantly to the pump and arc discharge occurs consistently due to the water on the connector, the wire on the pump connector will burn (refer Figure 2) and cause erroneous data to be feedback to the microcontroller about the speed of pump rotation, triggering the H2O alarm.
